Initial measurement of filter N3SH40-3 showed poor return loss and poor passband performance. Visual inspection showed damage to at least one inductor.

This filter is much more complex than the other N3SH filters and has custom toroidal inductors, so it was returned to the manufacturer for repair.

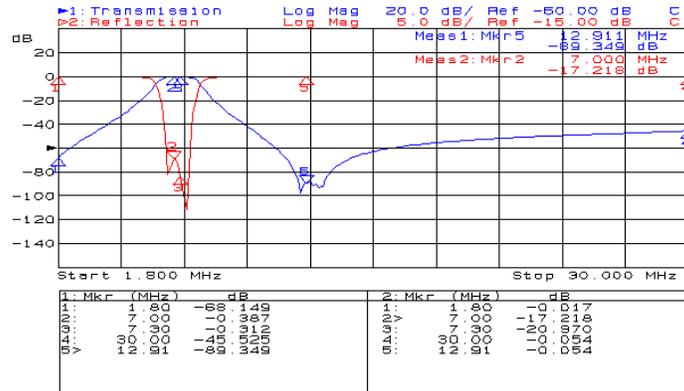
Response across the HF spectrum:

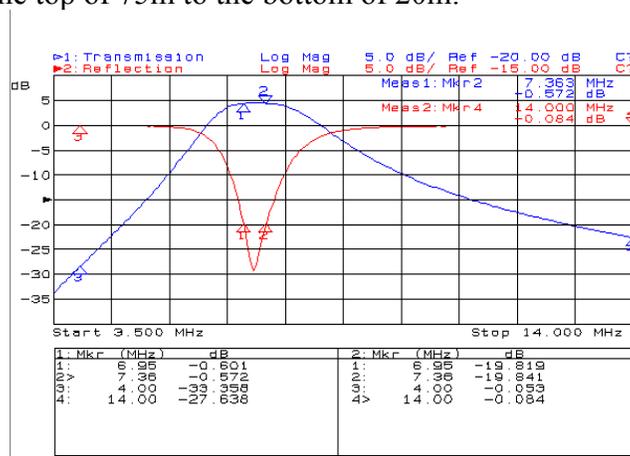
Next, we measured from the top of 75m to the bottom of 20m:

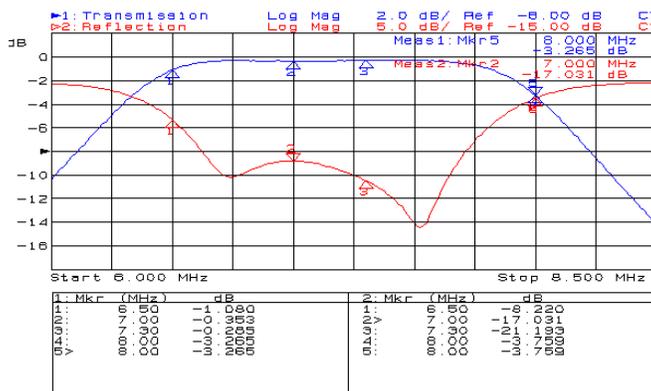
Finally, we took a close look at the passband:

This is a *nice* filter!
